WESTCHESTER TOWNSHIP MUSEUM

WINDOW REHABILITATION

COVER SHEET AND SCHEDULE
WESTCHESTER TOWNSHIP MUSEUM
700 W PORTER, CHESTERTON, IN

PROJECT No.	2015-031
DRAWN BY:	DDB
CHECKED BY:	JLK/BAM
DATE	SEPTEMBER 2015
SHEET No.	A2.0

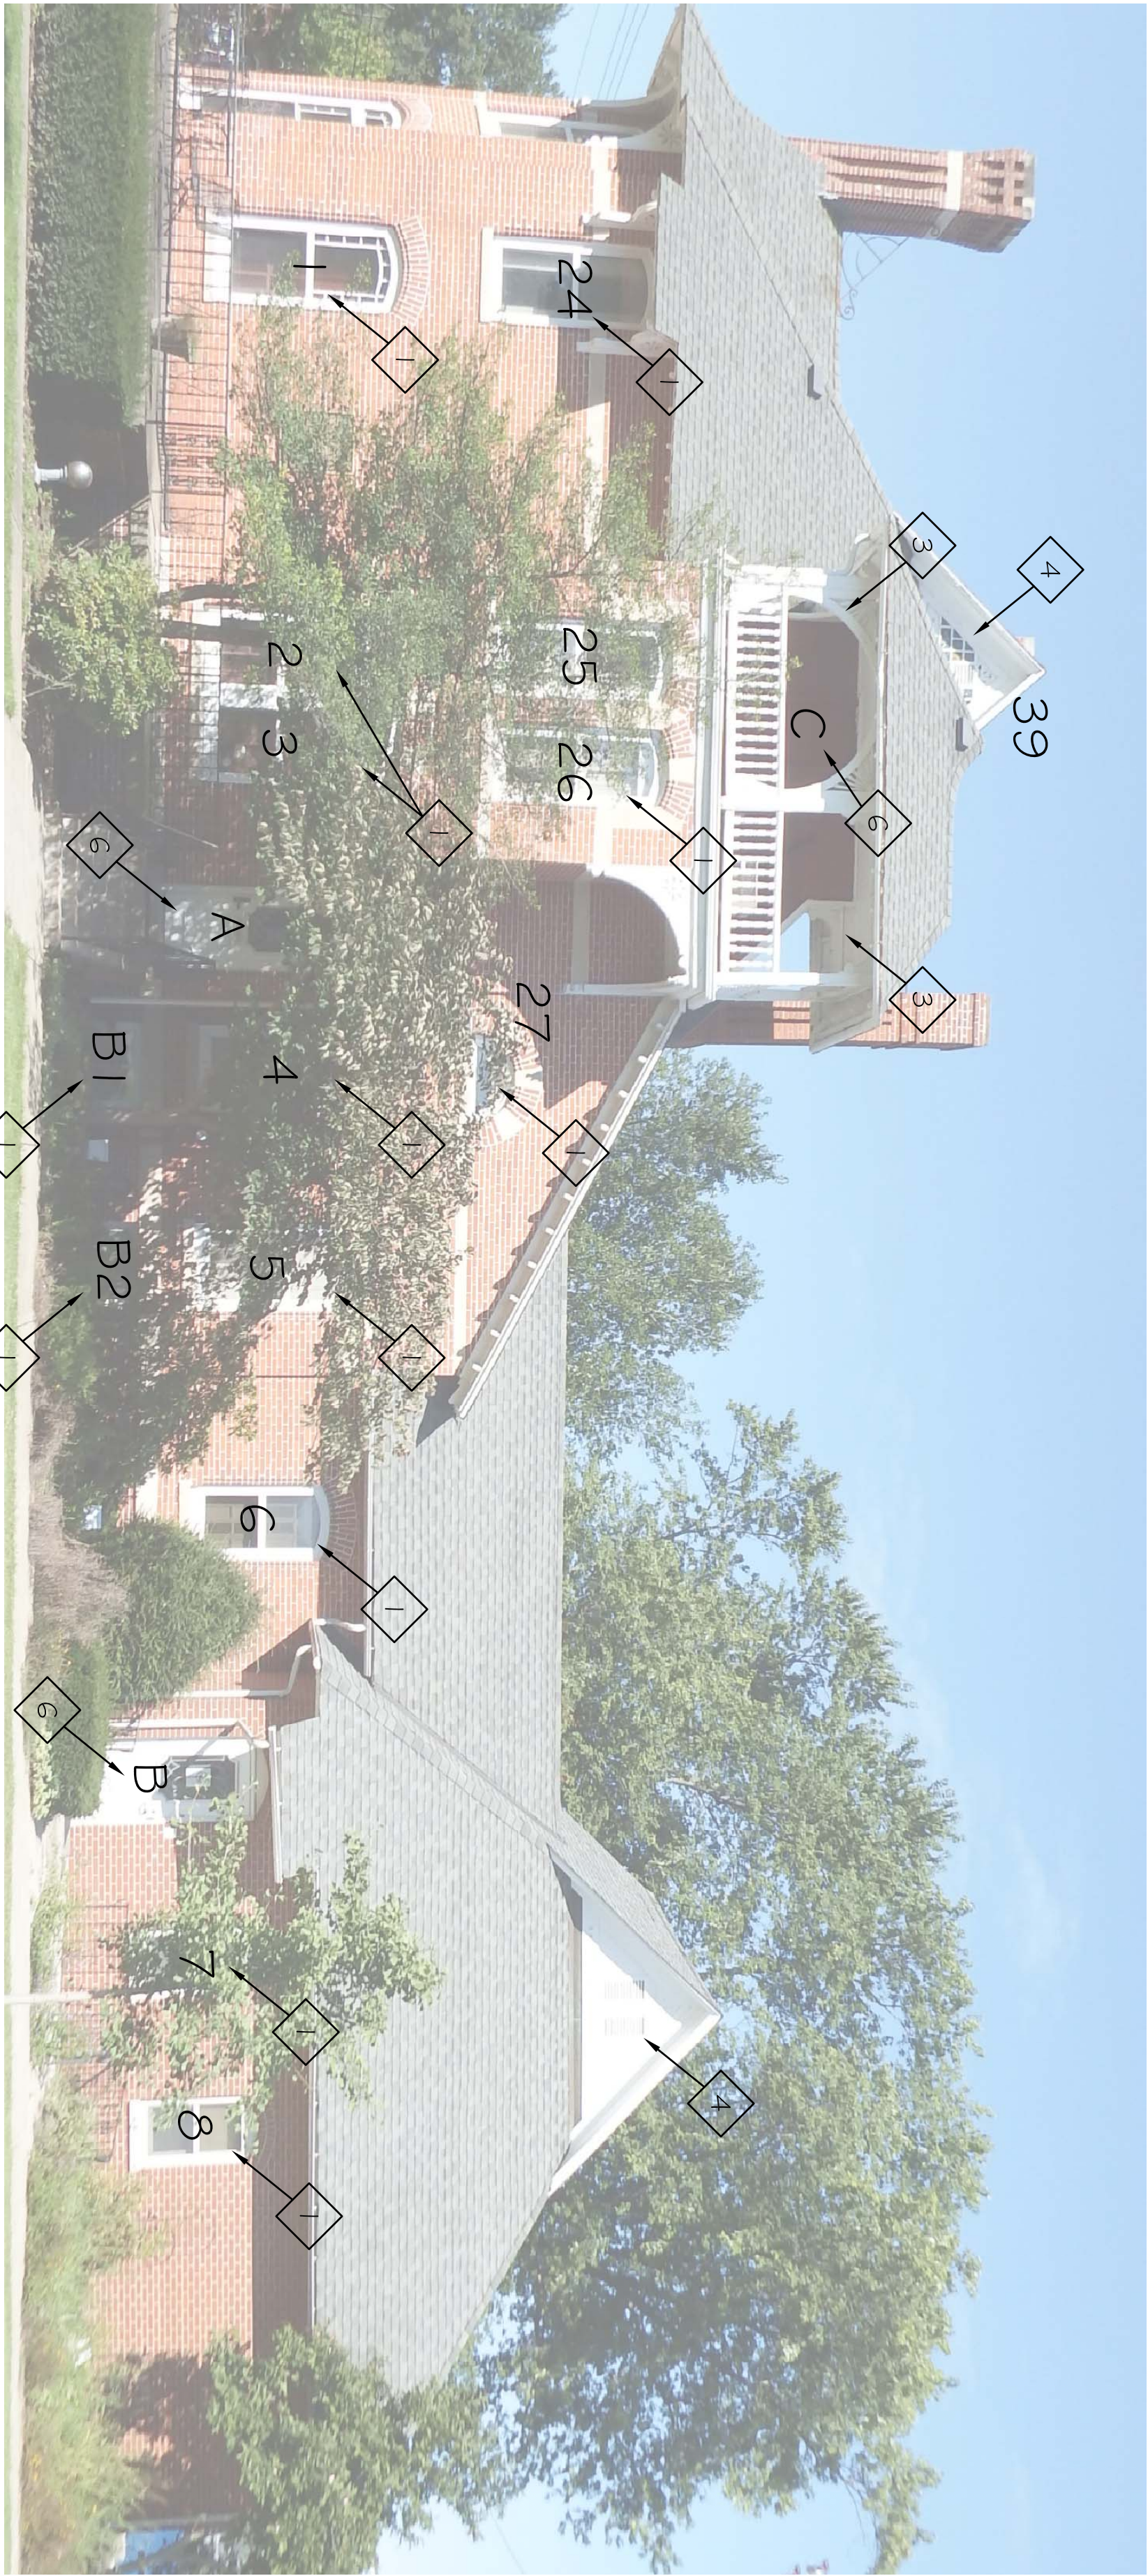
1 EAST ELEVATION PHOTOS
N.T.S.

- 1
- EXISTING WINDOW CONSISTS OF HISTORIC FRAMES AND SASHES WITH WOOD STORM WINDOW. REMOVE WOOD STORM WINDOW, CLEAN, PREP, AND REPAINT OFF SITE AND REINSTALL. CLEAN, PREP AND REPAINT HISTORIC FRAMES, WINDOW SASHES, SILLS, TRIM, AND STOOLS. SEE DIVISION EIGHT SPECIFICATIONS FOR SPECIFIC DETAIL.
- 2
- CLEAN, PREP AND RE-PAINT HISTORIC WOOD PORTICO.
- 3
- CLEAN, PREP AND RE-PAINT HISTORIC WOOD PORTICO, TRIM, RAILING AND BRACKETS.
- 4
- CLEAN, PREP AND RE-PAINT EXISTING WOOD GABLE TRIM, SOFFIT AND FASCIA.
- 5
- CLEAN, PREP AND RE-PAINT EXISTING HISTORIC WOOD DORMER, WINDOW FRAMES, WINDOW SASHES, DECORATIVE TRIMS, SOFFIT, FASCIA AND OUTRIGGERS.
- 6
- CLEAN, PREP AND RE-PAINT EXISTING HISTORIC WOOD DOOR AND TRANSOM.
- 7
- CLEAN, PREP AND RE-PAINT EXISTING HISTORIC SOFFIT, OUTRIGGERS AND BRACKETS.

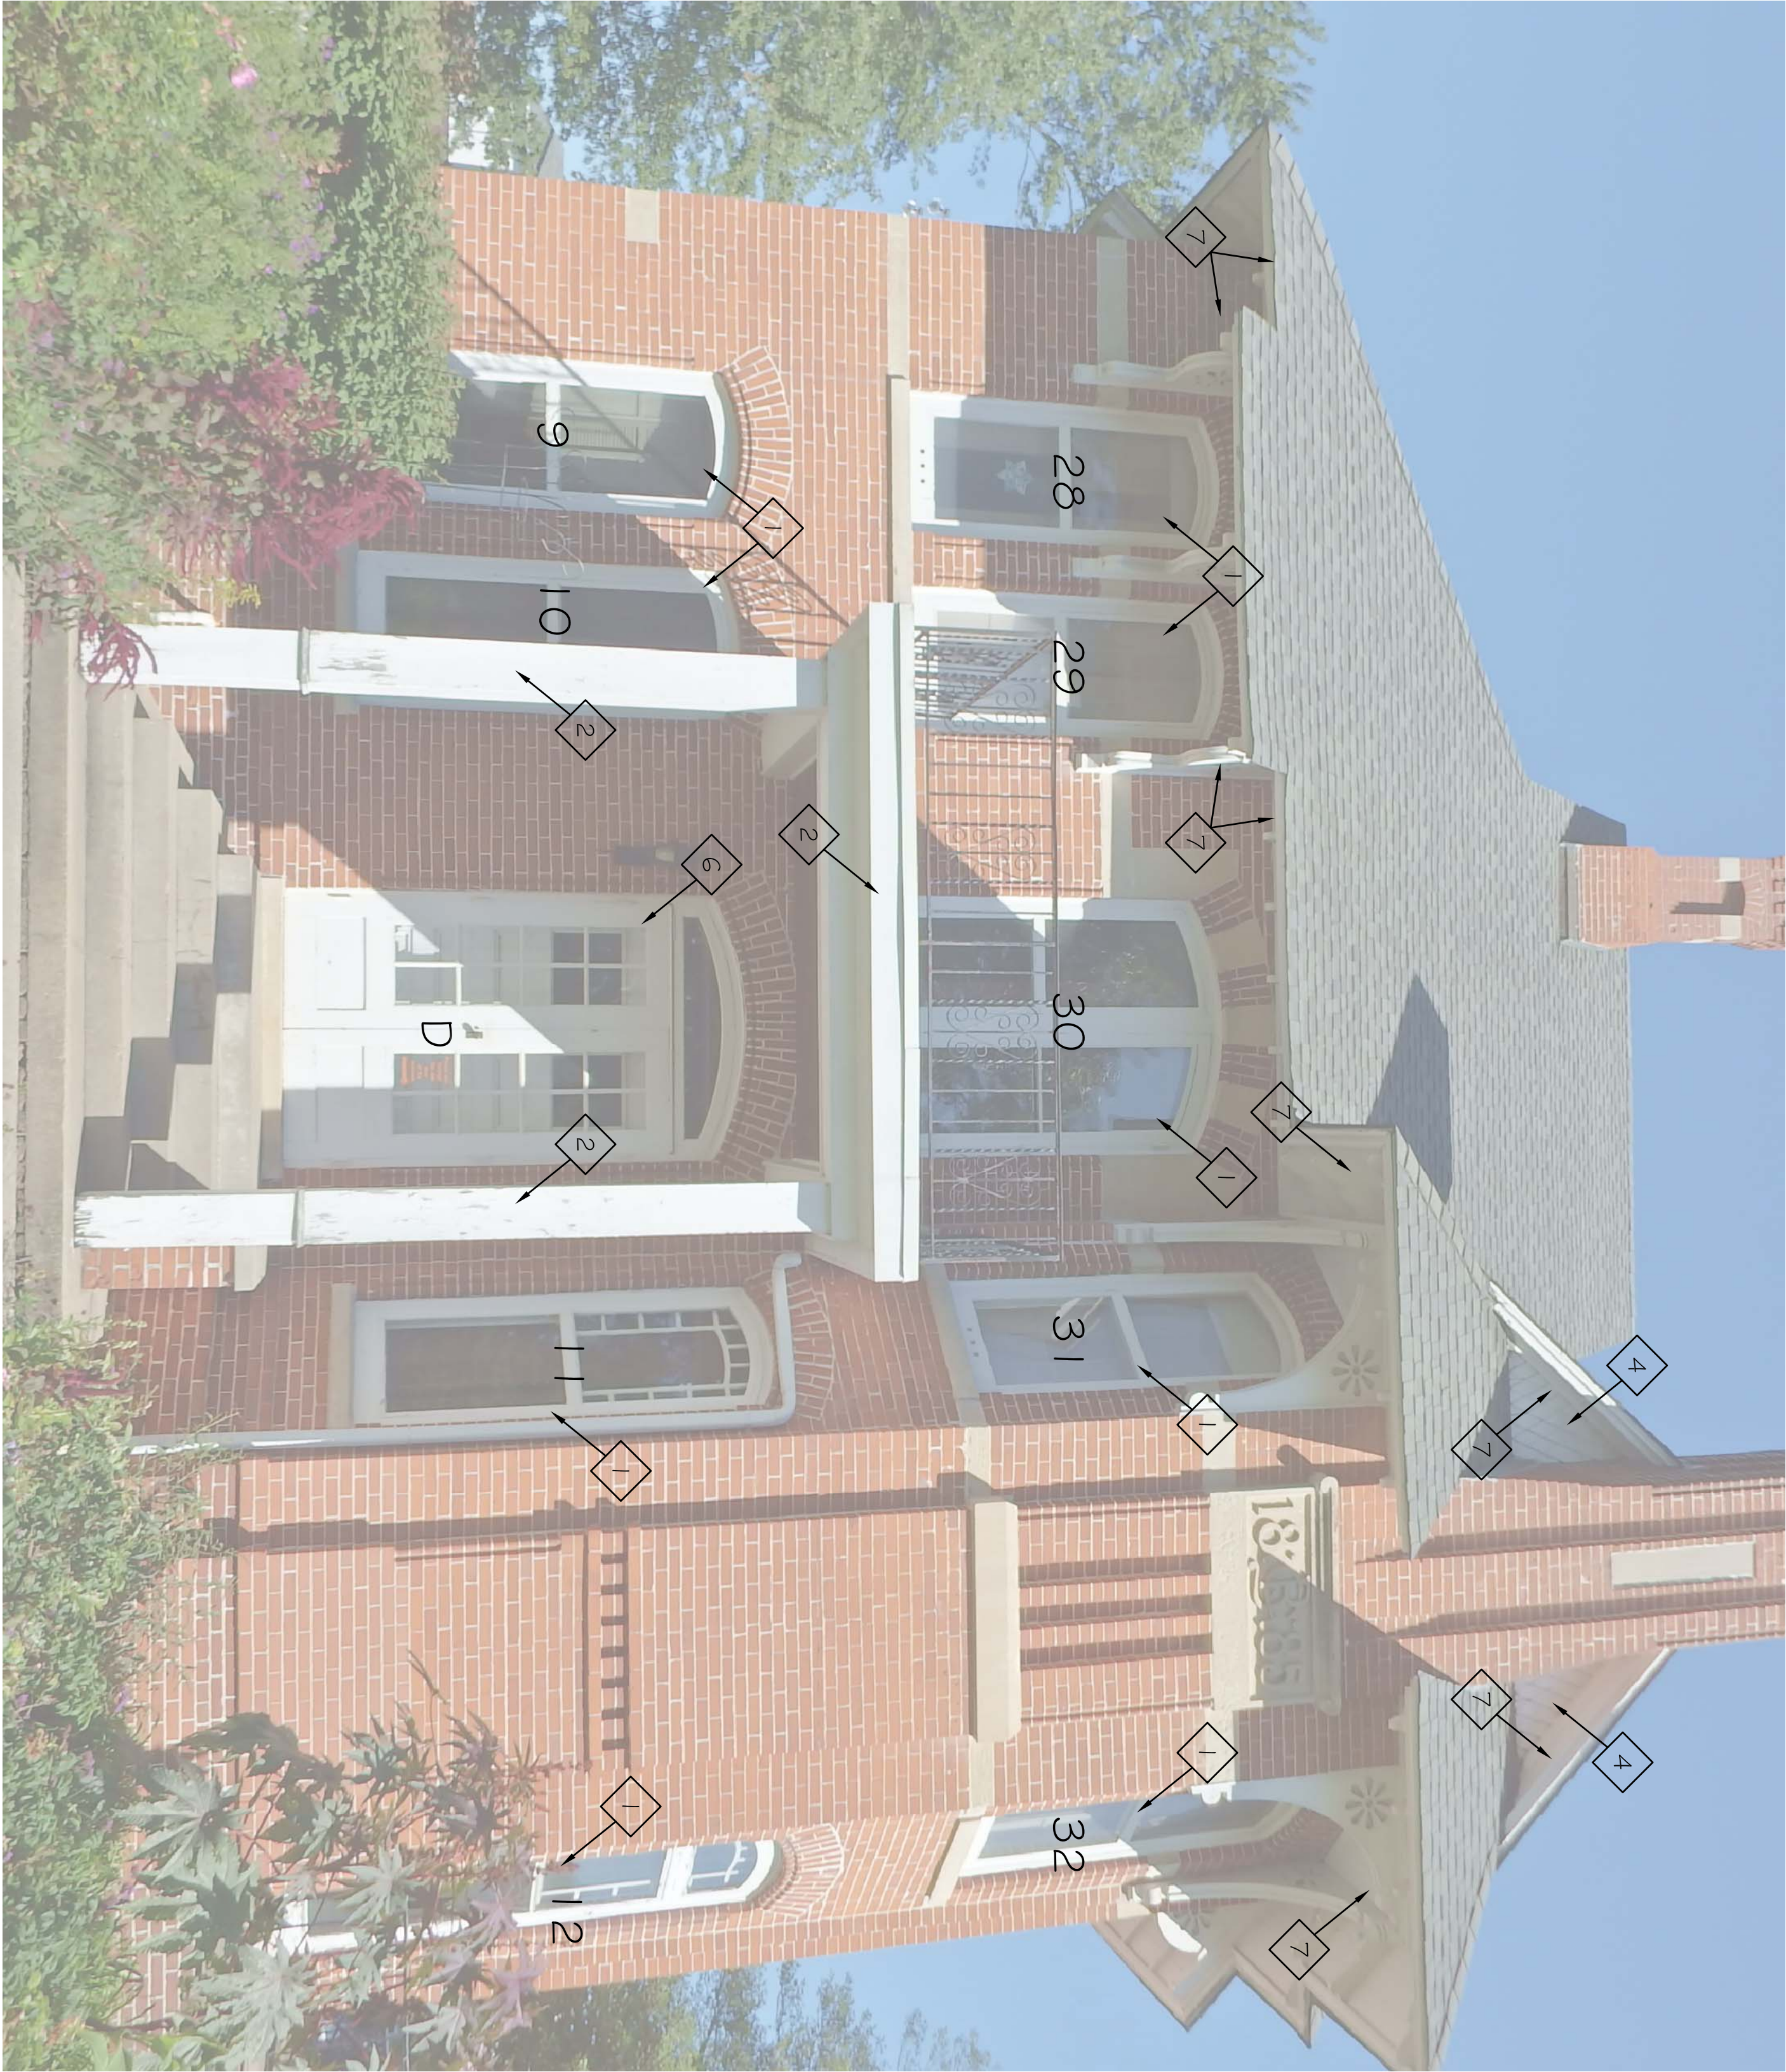
2 SOUTH ELEVATION PHOTO
N.T.S.

- 1 EXISTING WINDOW CONSISTS OF HISTORIC FRAMES AND SASHES WITH WOOD STORM WINDOW. REMOVE WOOD STORM WINDOW, CLEAN, PREP, AND REPAINT OFF SITE AND REINSTALL. CLEAN, PREP AND REPAINT HISTORIC FRAMES, WINDOW SASHES, SILLS, TRIM, AND STOOLS. SEE DIVISION EIGHT SPECIFICATIONS FOR SPECIFIC DETAIL.
- 2 CLEAN, PREP AND RE-PAINT HISTORIC WOOD PORTICO.
- 3 CLEAN, PREP AND RE-PAINT HISTORIC WOOD PORTICO, TRIM, RAILING AND BRACKETS.
- 4 CLEAN, PREP AND RE-PAINT EXISTING WOOD GABLE TRIM, SOFFIT AND FASCIA.
- 5 CLEAN, PREP AND RE-PAINT EXISTING HISTORIC WOOD DORMER, WINDOW FRAMES, WINDOW SASHES, DECORATIVE TRIMS, SOFFIT, FASCIA AND OUTRIGGERS.
- 6 CLEAN, PREP AND RE-PAINT EXISTING HISTORIC WOOD DOOR AND TRANSOM.
- 7 CLEAN, PREP AND RE-PAINT EXISTING HISTORIC SOFFIT, OUTRIGGERS AND BRACKETS.

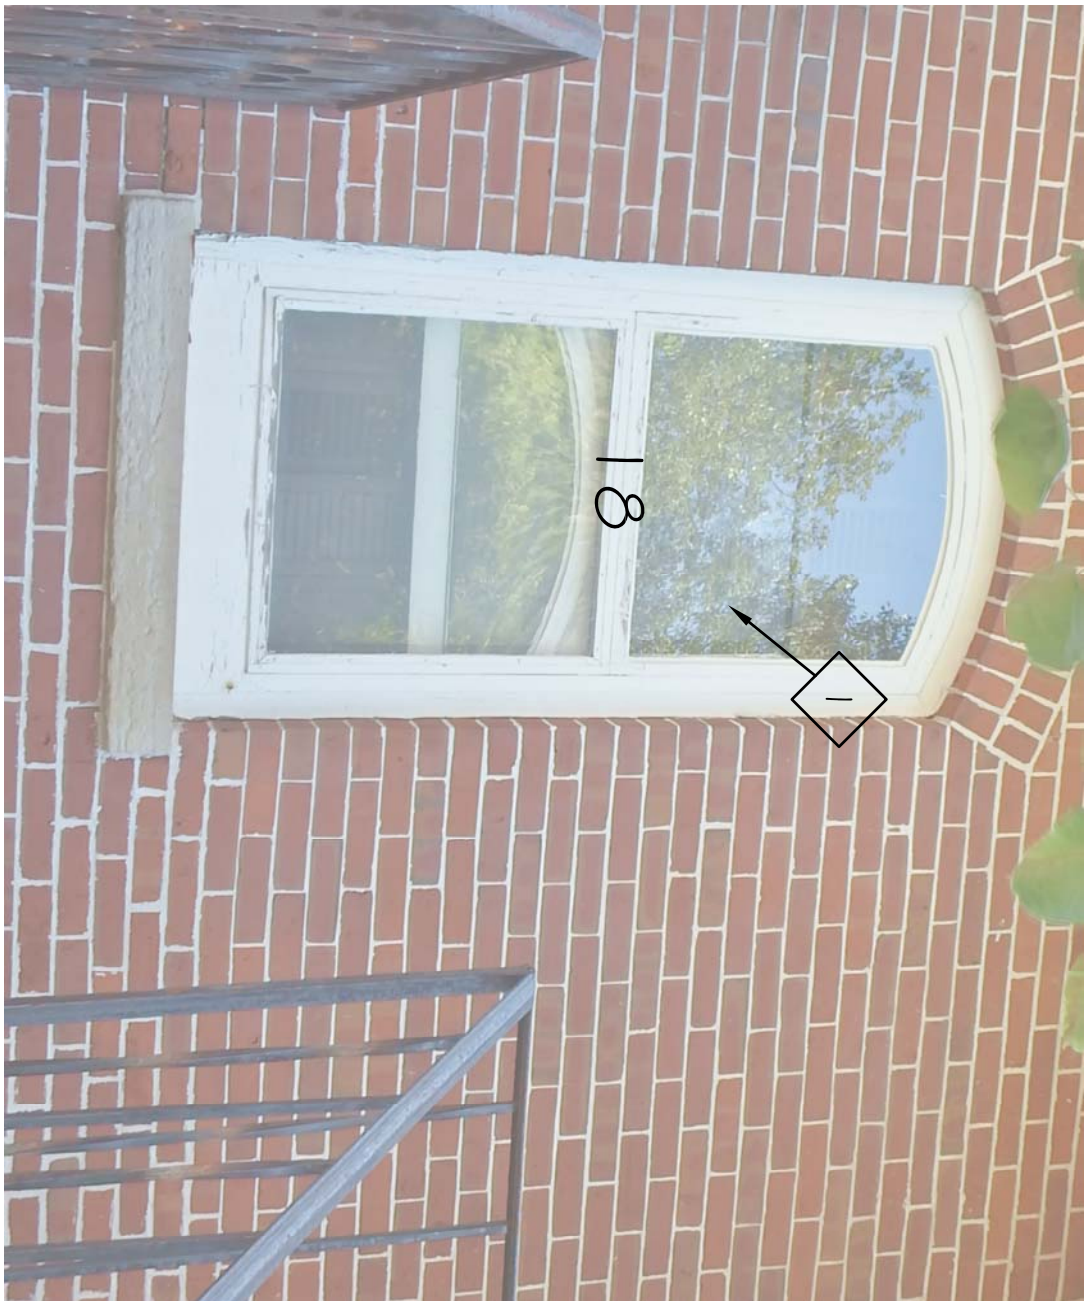
4 WEST ELEVATION PHOTO
N.T.S.

- 1 EXISTING WINDOW CONSISTS OF HISTORIC FRAMES AND SASHES WITH WOOD STORM WINDOW. REMOVE WOOD STORM WINDOW, CLEAN, PREP, AND REPAINT OFF SITE AND REINSTALL. CLEAN, PREP AND REPAINT HISTORIC FRAMES, WINDOW SASHES, SILLS, TRIM, AND STOOLS. SEE DIVISION EIGHT SPECIFICATIONS FOR SPECIFIC DETAIL.
- 2 CLEAN, PREP AND RE-PAINT HISTORIC WOOD PORTICO.
- 3 CLEAN, PREP AND RE-PAINT HISTORIC WOOD PORTICO, TRIM, RAILING AND BRACKETS.
- 4 CLEAN, PREP AND RE-PAINT EXISTING WOOD GABLE TRIM, SOFFIT AND FASCIA.
- 5 CLEAN, PREP AND RE-PAINT EXISTING HISTORIC WOOD DORMER, WINDOW FRAMES, WINDOW SASHES, DECORATIVE TRIMS, SOFFIT, FASCIA AND OUTRIGGERS.
- 6 CLEAN, PREP AND RE-PAINT EXISTING HISTORIC WOOD DOOR AND TRANSOM.
- 7 CLEAN, PREP AND RE-PAINT EXISTING HISTORIC SOFFIT, OUTRIGGERS AND BRACKETS.

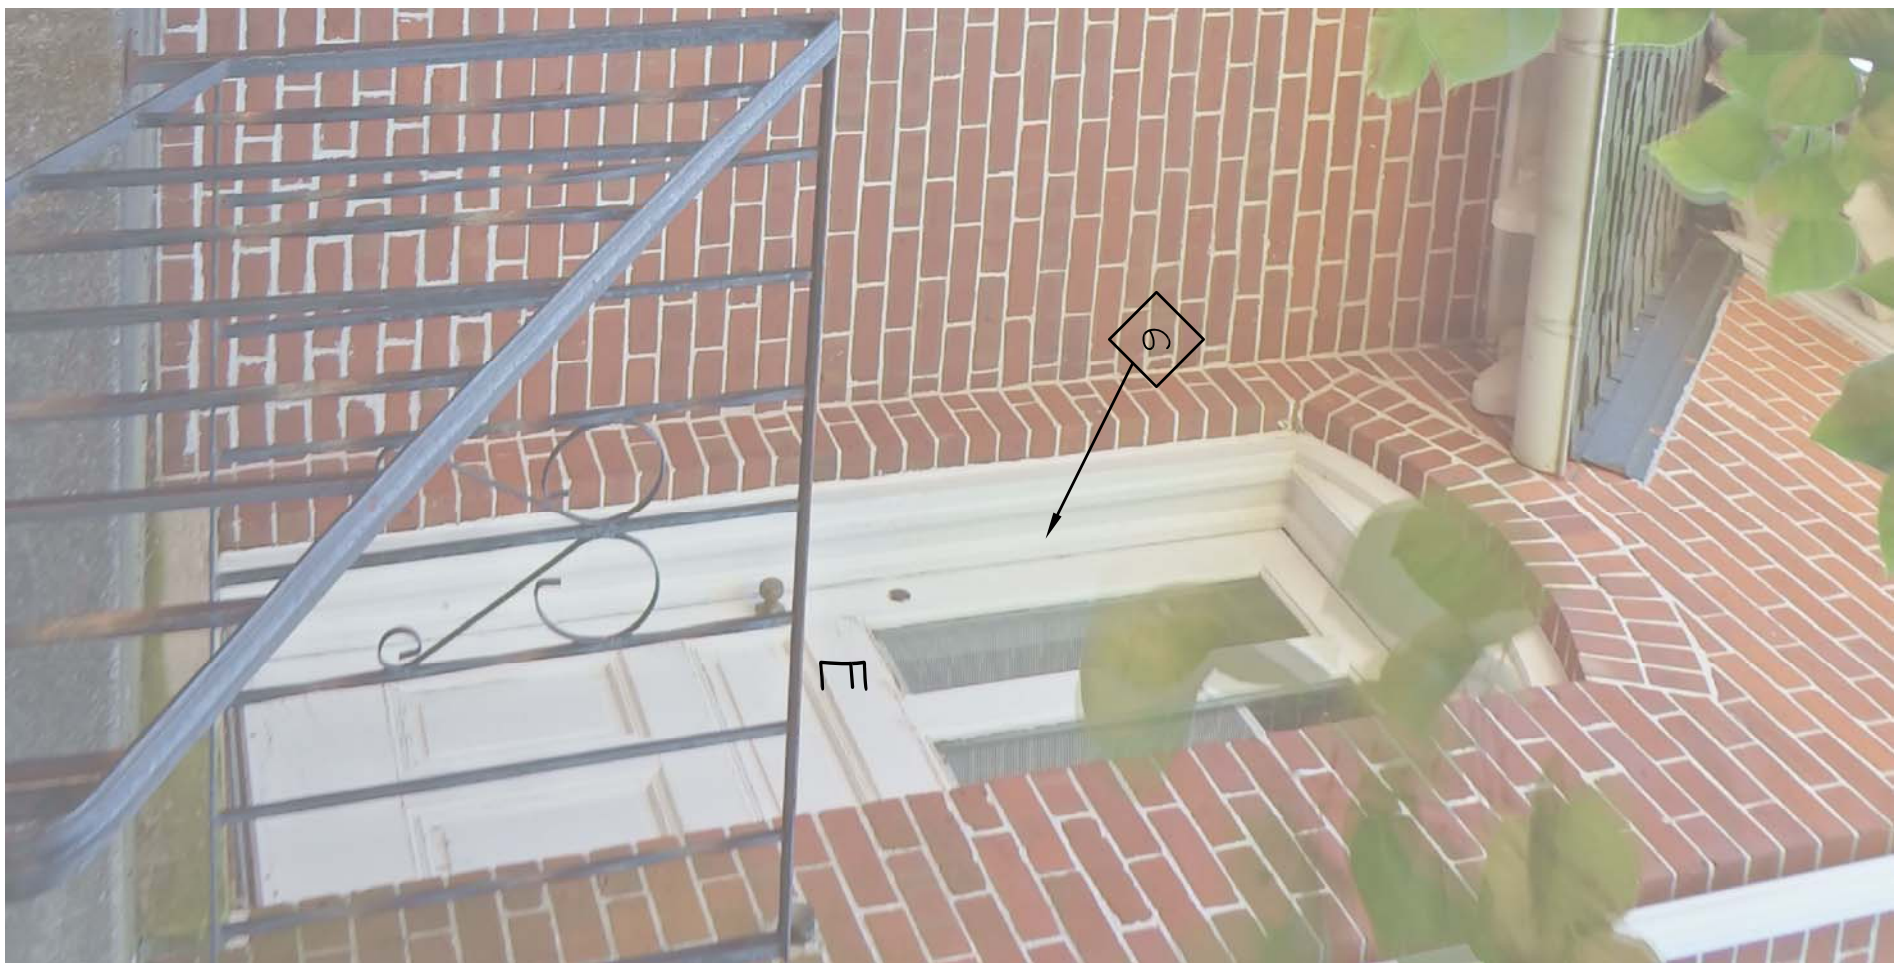
10 NORTH ELEVATION PHOTO
N.T.S.

- 1 EXISTING WINDOW CONSISTS OF HISTORIC FRAMES AND SASHES WITH WOOD STORM WINDOW. REMOVE WOOD STORM WINDOW, CLEAN, PREP, AND REPAINT OFF SITE AND REINSTALL. CLEAN, PREP AND REPAINT HISTORIC FRAMES, WINDOW SASHES, SILLS, TRIM, AND STOOLS. SEE DIVISION EIGHT SPECIFICATIONS FOR SPECIFIC DETAIL.
- 2 CLEAN, PREP AND RE-PAINT HISTORIC WOOD PORTICO.
- 3 CLEAN, PREP AND RE-PAINT HISTORIC WOOD PORTICO, TRIM, RAILING AND BRACKETS.
- 4 CLEAN, PREP AND RE-PAINT EXISTING WOOD GABLE TRIM, SOFFIT AND FASCIA.
- 5 CLEAN, PREP AND RE-PAINT EXISTING HISTORIC WOOD DORMER, WINDOW FRAMES, WINDOW SASHES, DECORATIVE TRIMS, SOFFIT, FASCIA AND OUTRIGGERS.
- 6 CLEAN, PREP AND RE-PAINT EXISTING HISTORIC WOOD DOOR AND TRANSOM.
- 7 CLEAN, PREP AND RE-PAINT EXISTING HISTORIC SOFFIT, OUTRIGGERS AND BRACKETS.
