EAST WINDOW REHABILITIATION WESTCHESTER TOWNSHIP MUSEUM 700 W PORTER, CHESTERTON, IN

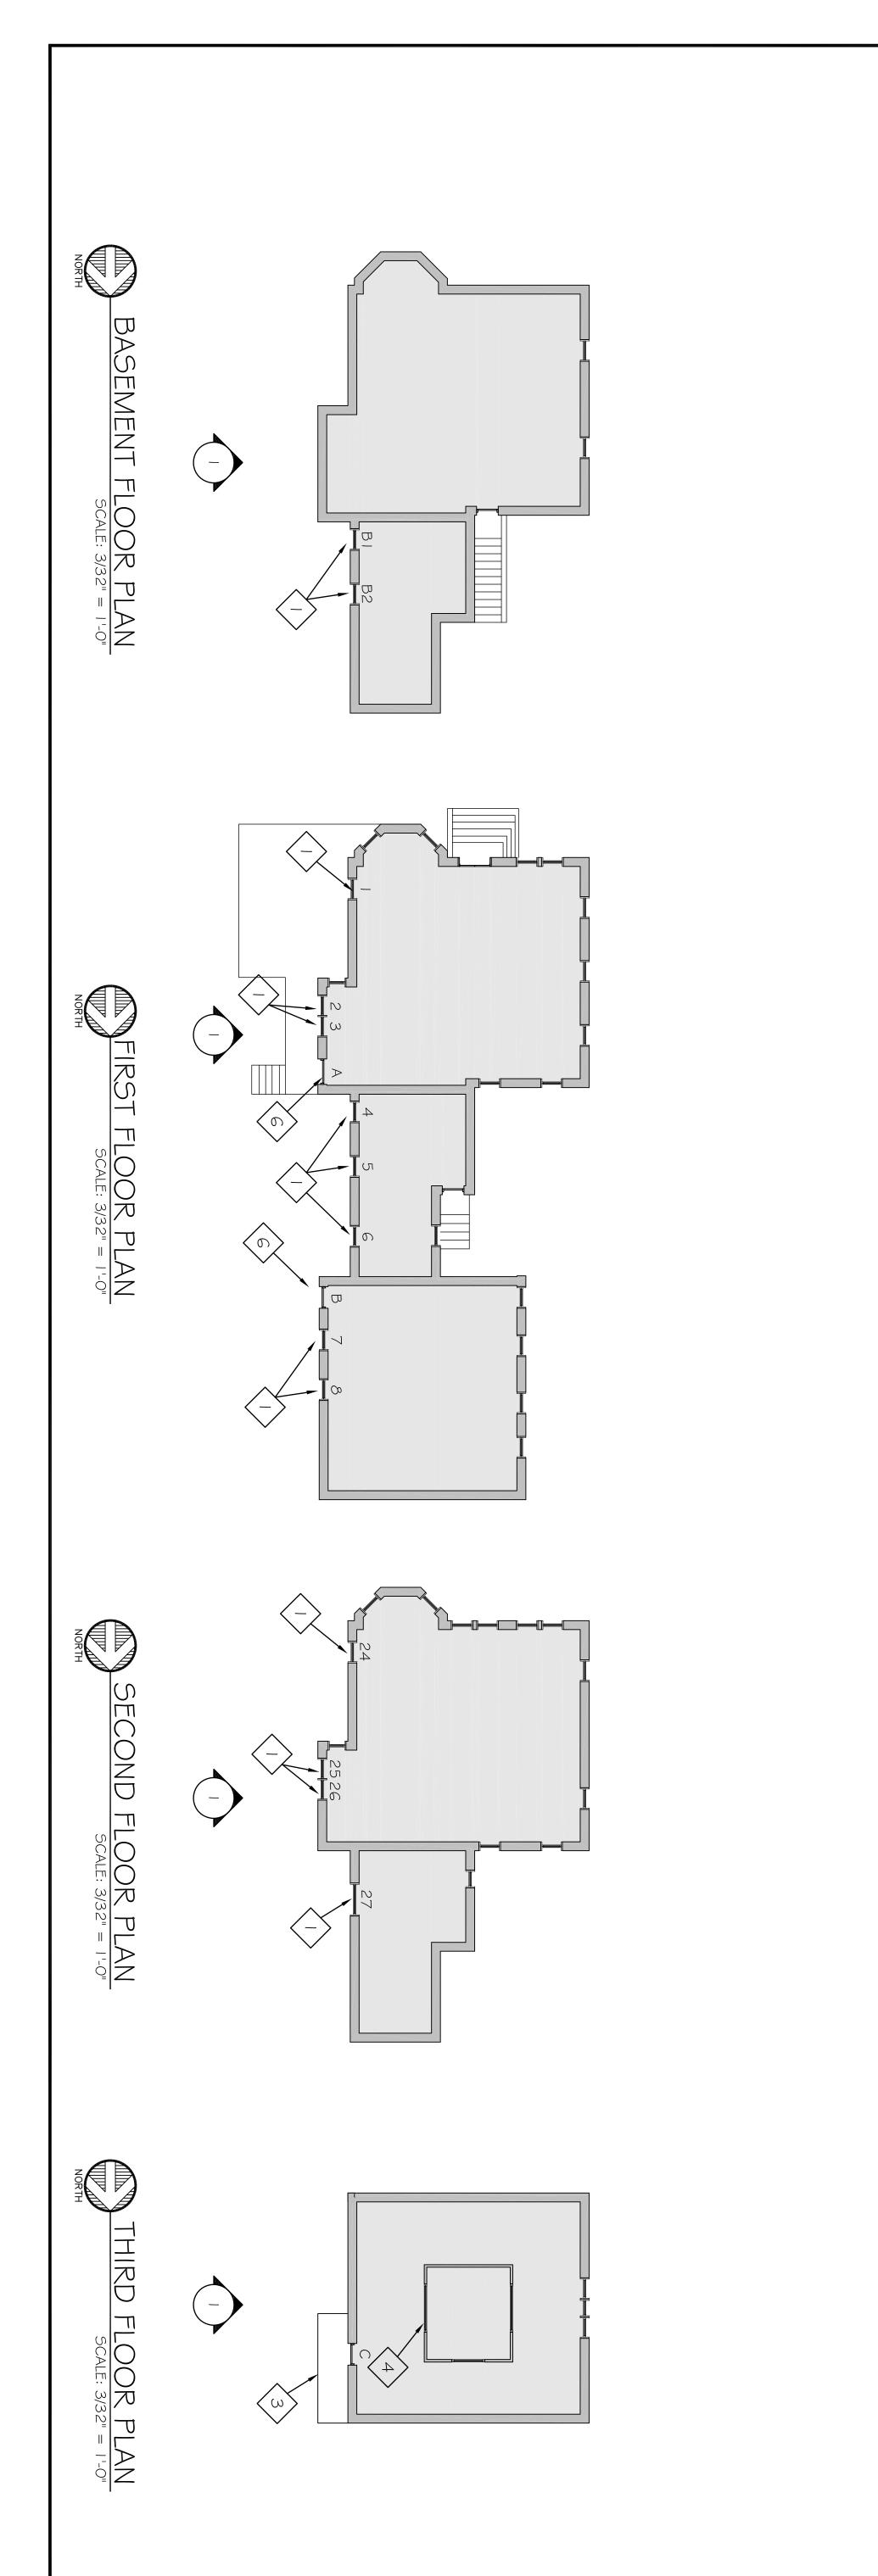
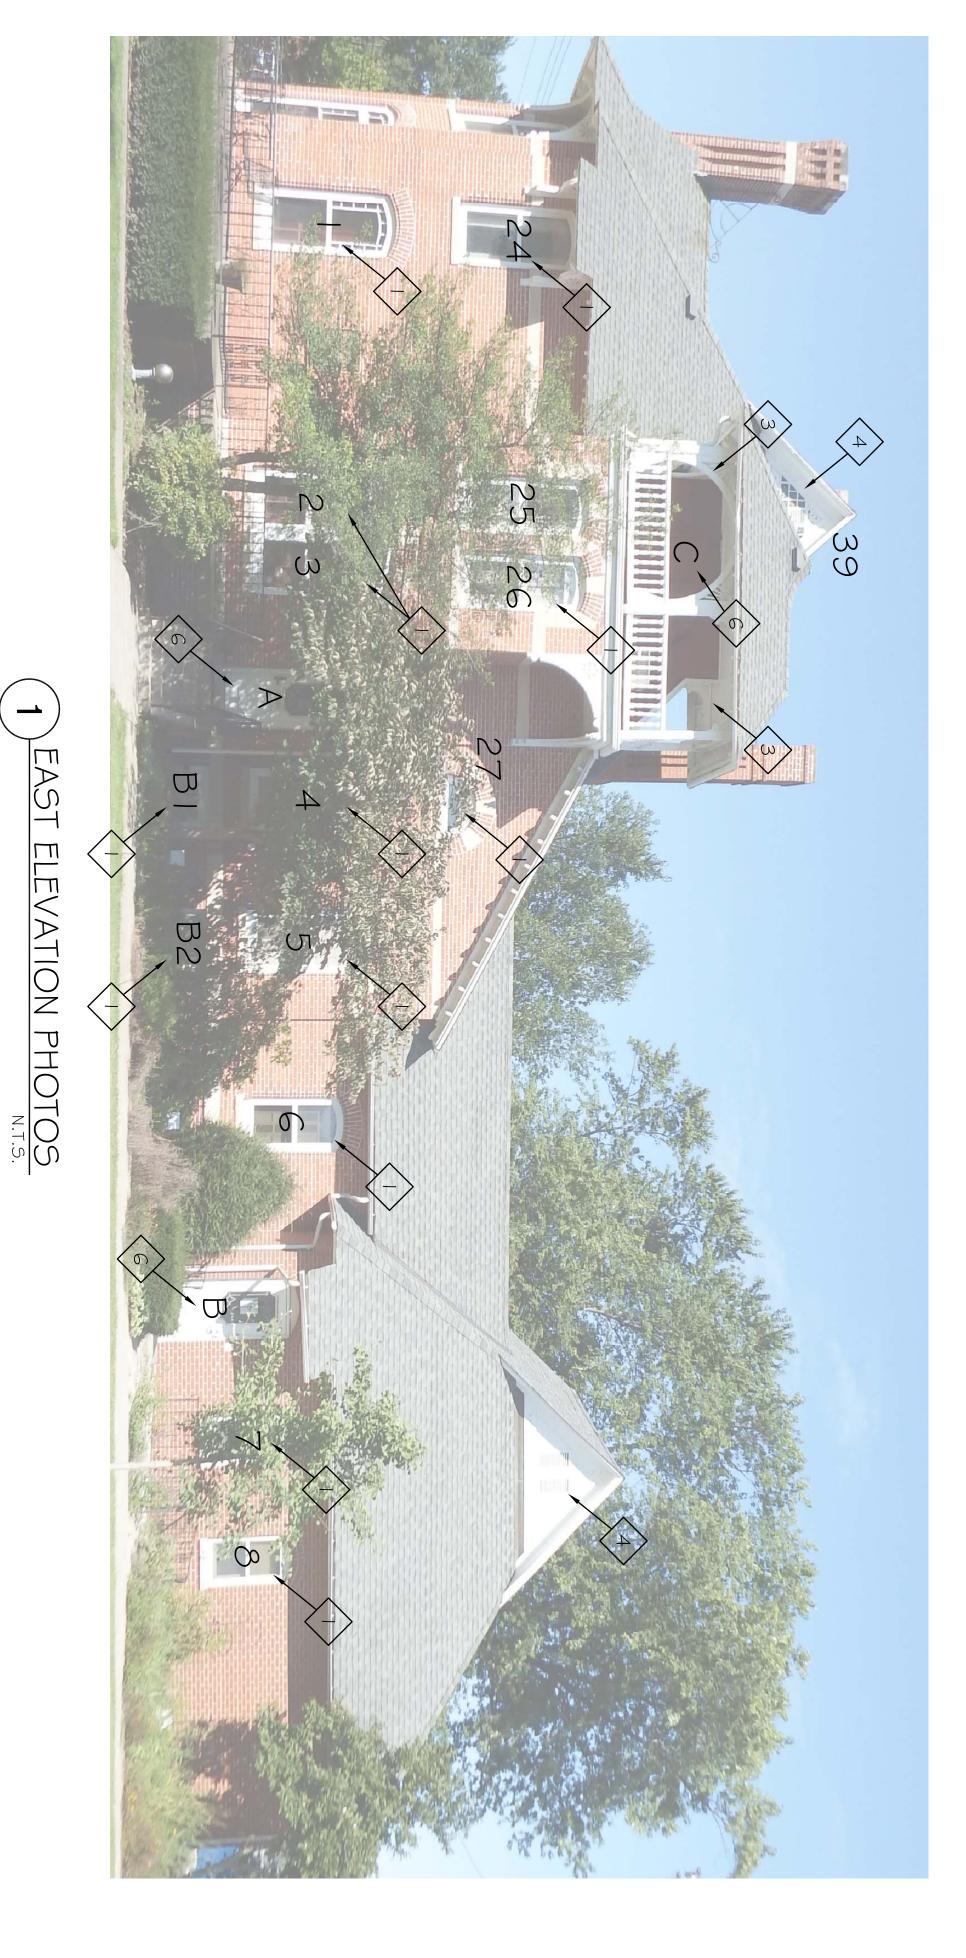
FLOOR PLAN KEYNOTES:

- EXISTING WINDOW CONSISTS OF HISTORIC FRAMES AND SASHES WITH WOOD STORM WINDOW. REMOVE WOOD STORM WINDOW, CLEAN, PREP, AND REPAINT OFF SITE AND REINSTALL. CLEAN, PREP AND REPAINT HISTORIC FRAMES, WINDOW SASHES, SILLS, TRIM, AND STOOLS. SEE DIVISION EIGHT SPECIFICATIONS FOR SPECIFIC DETAIL.
- CLEAN, PREP AND RE-PAINT HISTORIC WOOD PORTICO. CLEAN, PREP AND RE-PAINT HISTORIC WOOD PORTICO, TRIM, RAILING AND BRACKETS.
- CLEAN, PREP AND RE-PAINT EXISTING WOOD GABLE TRIM, SOFFIT AND FASCIA.
- CLEAN, PREP AND RE-PAINT EXISTING HISTORIC WOOD DORMER, WINDOW FRAMES, WINDOW SASHES, DECORATIVE TRIMS, SOFFIT, FASCIA AND OUTRIGGERS. CLEAN, PREP AND RE-PAINT EXISTING HISTORIC WOOD DOOR AND TRANSOM.
- CLEAN, PREP AND RE-PAINT EXISTING HISTORIC SOFFIT, OUTRIGGERS AND BRACKETS.

WOOD COMPONENTS HAVE DETERIORATED BEYOND REPAIR IN A NUMBER OF LOCATIONS AND SHA; LL BE REPLACED WITH NEW COMPONENTS OF POPLAR OF DIMENSIONS TO MATCH EXISTING EXACTLY. NOMINAL SIZE LUMBER SHALL NOT BE ACCEPTABLE.
