WEST WINDOW REHABILITATION  
WESTCHESTER TOWNSHIP MUSEUM  
700 W PORTER, CHESTERTON, IN

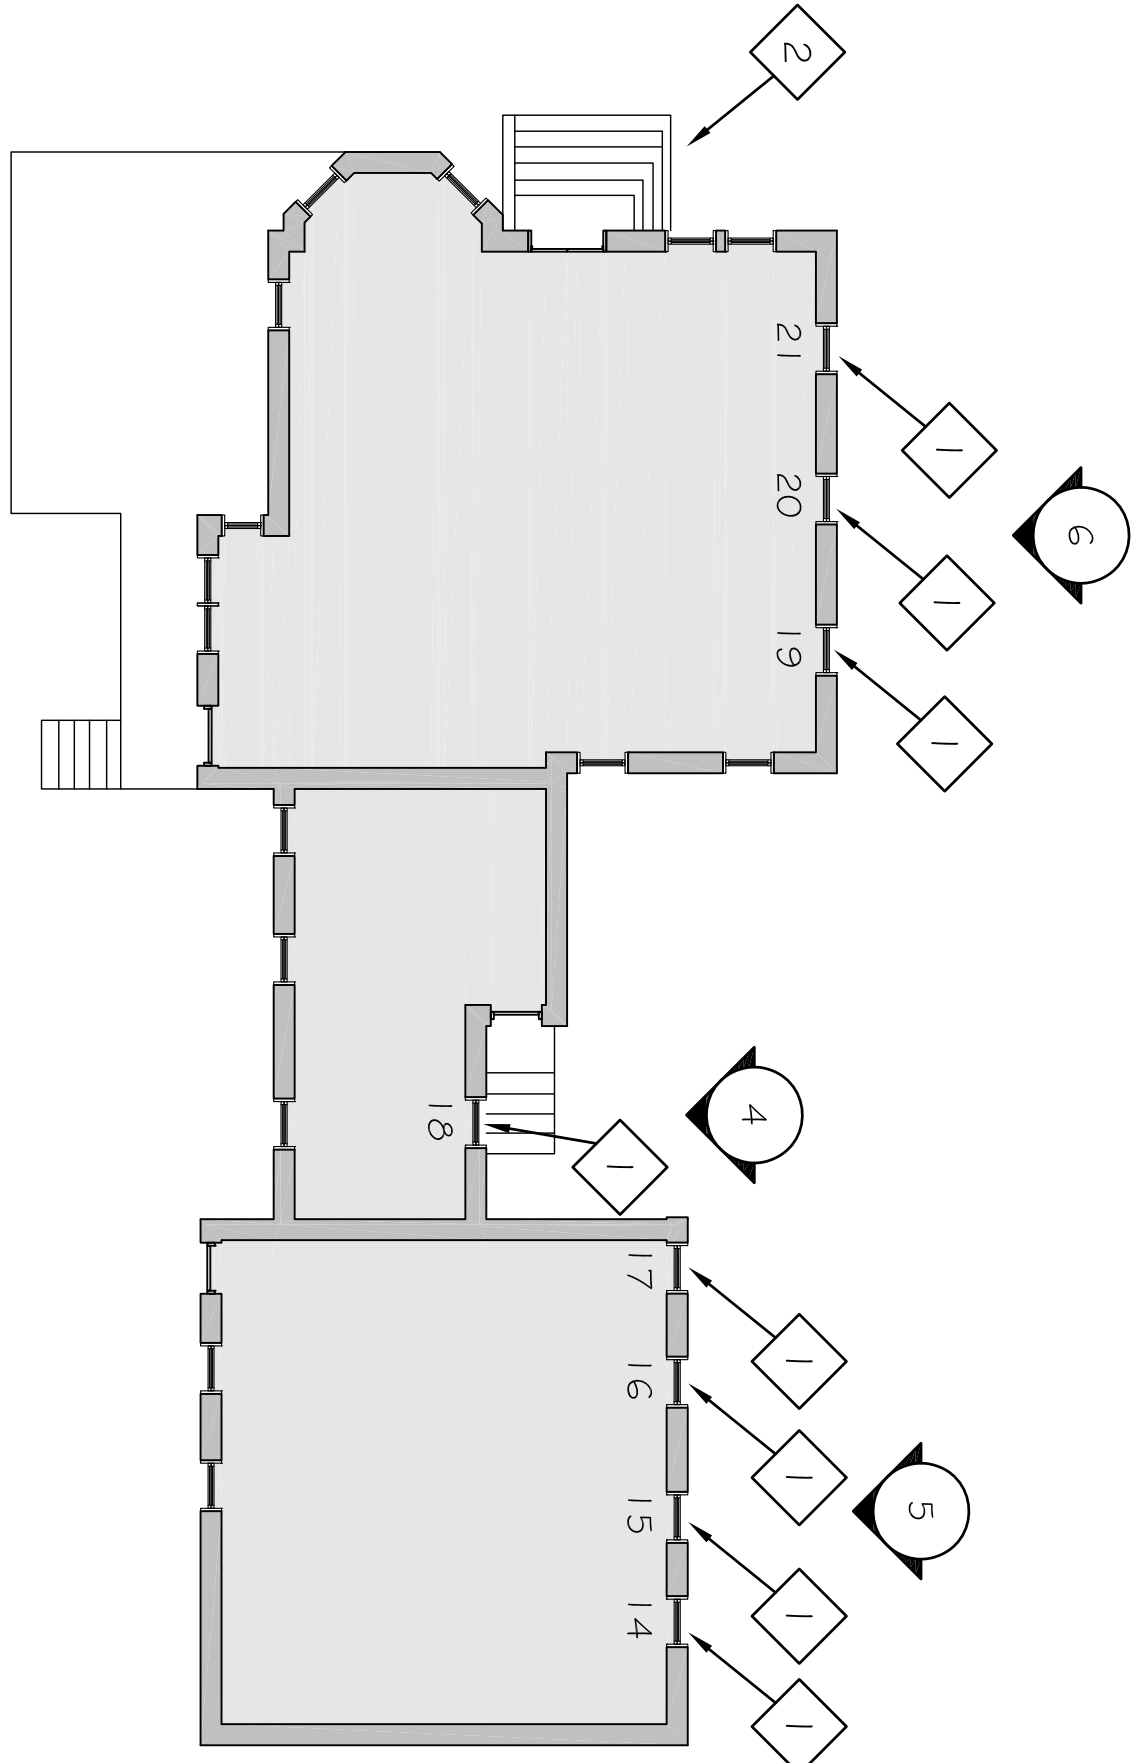
FIRST FLOOR PLAN  
SCALE: 3/32" = 1'-0"  
NORTH

- 1 EXISTING WINDOW CONSISTS OF HISTORIC FRAMES AND SASHES WITH WOOD STORM WINDOW. REMOVE WOOD STORM WINDOW, CLEAN, PREP, AND REPAINT OFF SITE AND REINSTALL. CLEAN, PREP AND REPAINT HISTORIC FRAMES, WINDOW SASHES, SILLS, TRIM, AND STOOLS. SEE DIVISION EIGHT SPECIFICATIONS FOR SPECIFIC DETAIL.
- 2 CLEAN, PREP AND RE-PAINT HISTORIC WOOD PORTICO.
- 3 CLEAN, PREP AND RE-PAINT HISTORIC WOOD PORTICO, TRIM, RAILING AND BRACKETS.
- 4 CLEAN, PREP AND RE-PAINT EXISTING WOOD GABLE TRIM, SOFFIT AND FASCIA.
- 5 CLEAN, PREP AND RE-PAINT EXISTING HISTORIC WOOD DORMER, WINDOW FRAMES, WINDOW SASHES, DECORATIVE TRIMS, SOFFIT, FASCIA AND OUTRIGGERS.
- 6 CLEAN, PREP AND RE-PAINT EXISTING HISTORIC WOOD DOOR AND TRANSOM.
- 7 CLEAN, PREP AND RE-PAINT EXISTING HISTORIC SOFFIT, OUTRIGGERS AND BRACKETS.

PROJECT NOTE:  
WOOD COMPONENTS HAVE DETERIORATED BEYOND REPAIR IN A NUMBER OF LOCATIONS AND SHALL BE REPLACED WITH NEW COMPONENTS OF POPLAR OF DIMENSIONS TO MATCH EXISTING EXACTLY. NOMINAL SIZE LUMBER SHALL NOT BE ACCEPTABLE.
